Manhole Inspection Summary

Manhole # S51W1_007MH

Insp Date: **6/2/09 1:16 PM**

Location Address: **1800 Chesapeake Ave.**

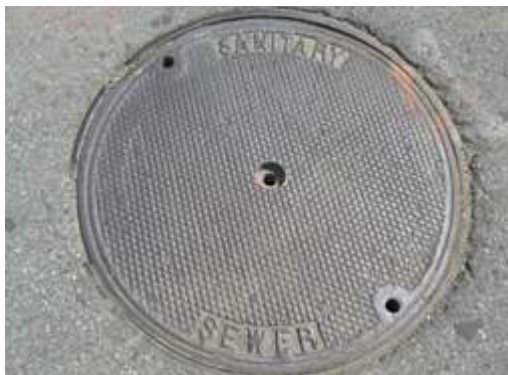
Cover

Condition: **Sound**

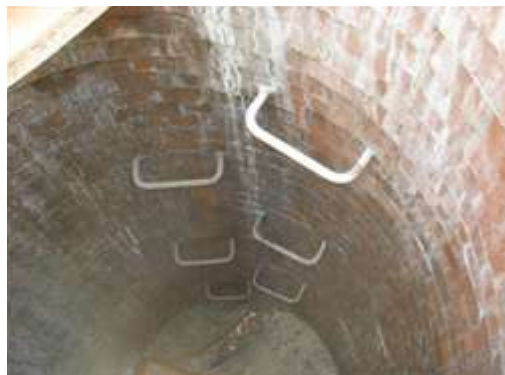
Steps

Count: **7** Missing: **0** ☐ Corroded

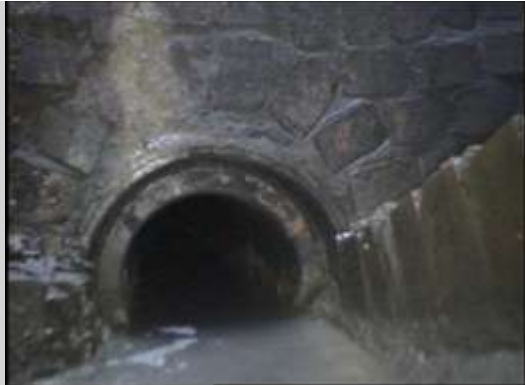
12 O'Clock Outflow

10 in. Circular Gravity Sewer
Pipe Out @ 12 O'Clock

Pipe Height: **14.4** (in.) Rod and Bar (Angled)
Pipe Material: **Clay** ☐ Pipe Lined
Invert Depth: **13.70** (ft.) Flow Characteristics: **Slow**
Deposits: ☒ None ☐ Mud ☐ Sludge ☐ Debris ☐ Grease
Silt Depth: (in.) Deposits Extent:
Infiltration: **None** Pipe Seal Cond: **Sound**

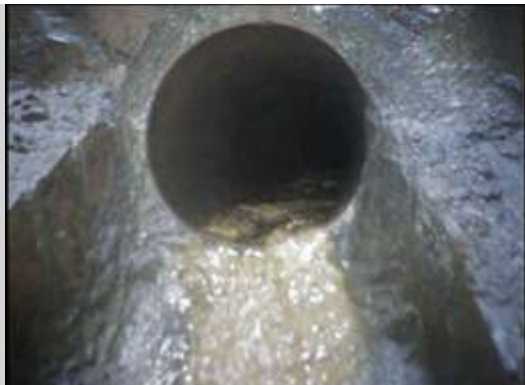
6 O'Clock Inflow

10 in. Circular Gravity Sewer
Pipe In @ 6 O'Clock

Pipe Height: **9.6** (in.) Rod and Bar (Angled)
Pipe Material: **Clay** ☐ Pipe Lined
Invert Depth: **12.25** (ft.) Flow Characteristics: **Slow**
Deposits: ☒ None ☐ Mud ☐ Sludge ☐ Debris ☐ Grease
Silt Depth: (in.) Deposits Extent:
Infiltration: **None** Pipe Seal Cond: **Sound**

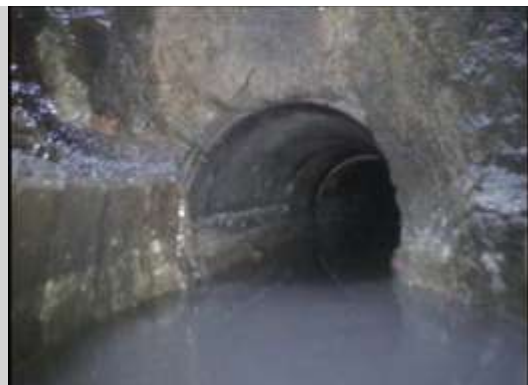
9 O'Clock Inflow

8 in. Circular Gravity Sewer

Pipe In @ 9 O'Clock

Pipe Height: **10.8** (in.) Rod and Bar (Angled)

Pipe Material: **Clay** ☐ Pipe Lined

Invert Depth: **13.40** (ft.) Flow Characteristics: **Slow**

Deposits: ☒ None ☐ Mud ☐ Sludge ☐ Debris ☐ Grease

Infiltration: **None** Pipe Seal Cond: **Sound**
